**Forensic meteorological investigation of local weather along Florida Highway 301,
near the intersection of N County Road 225.**

PREPARED ON: January 17, 2014
PREPARED FOR: Mr. Joshua Wilcox, Esq.
AFFILIATION: Wilcox and Jennings, P.A.
PREPARED BY: Megan Walker-Radtke, CCM

INCIDENT DATE: November 18, 2013
INCIDENT LOCATION: 2 mi north of Waldo, FL, along FL Hwy 301
at approximately (29.836N, 82.166W)

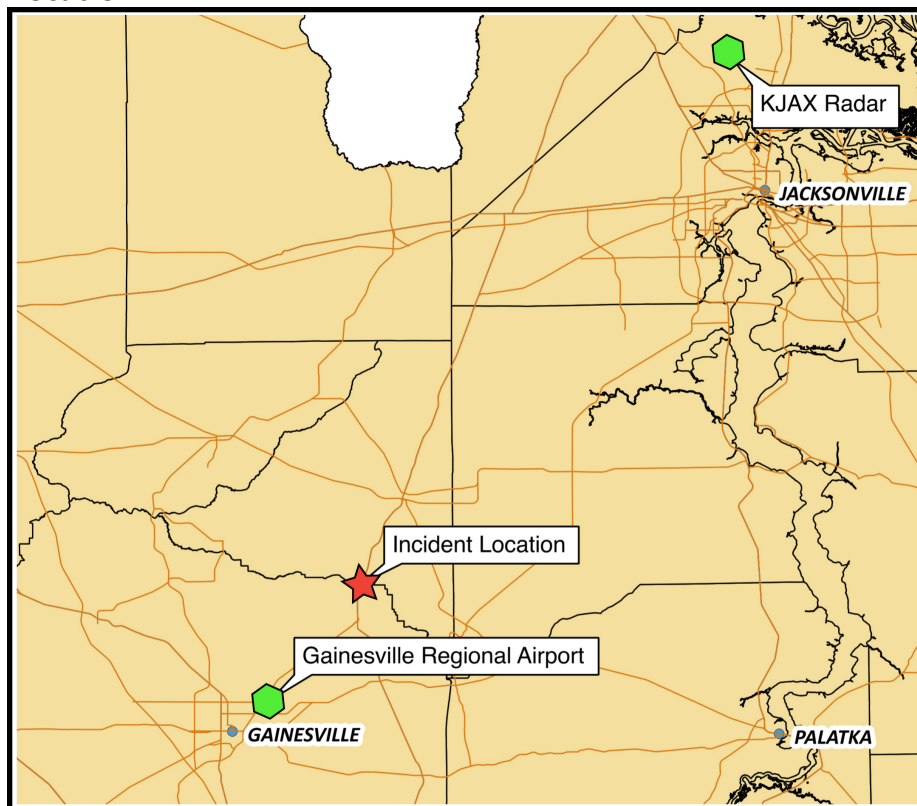
Figure 1: Layout of the incident location and relevant data sources, including the accident site, NEXRAD radar location, and weather reporting stations.

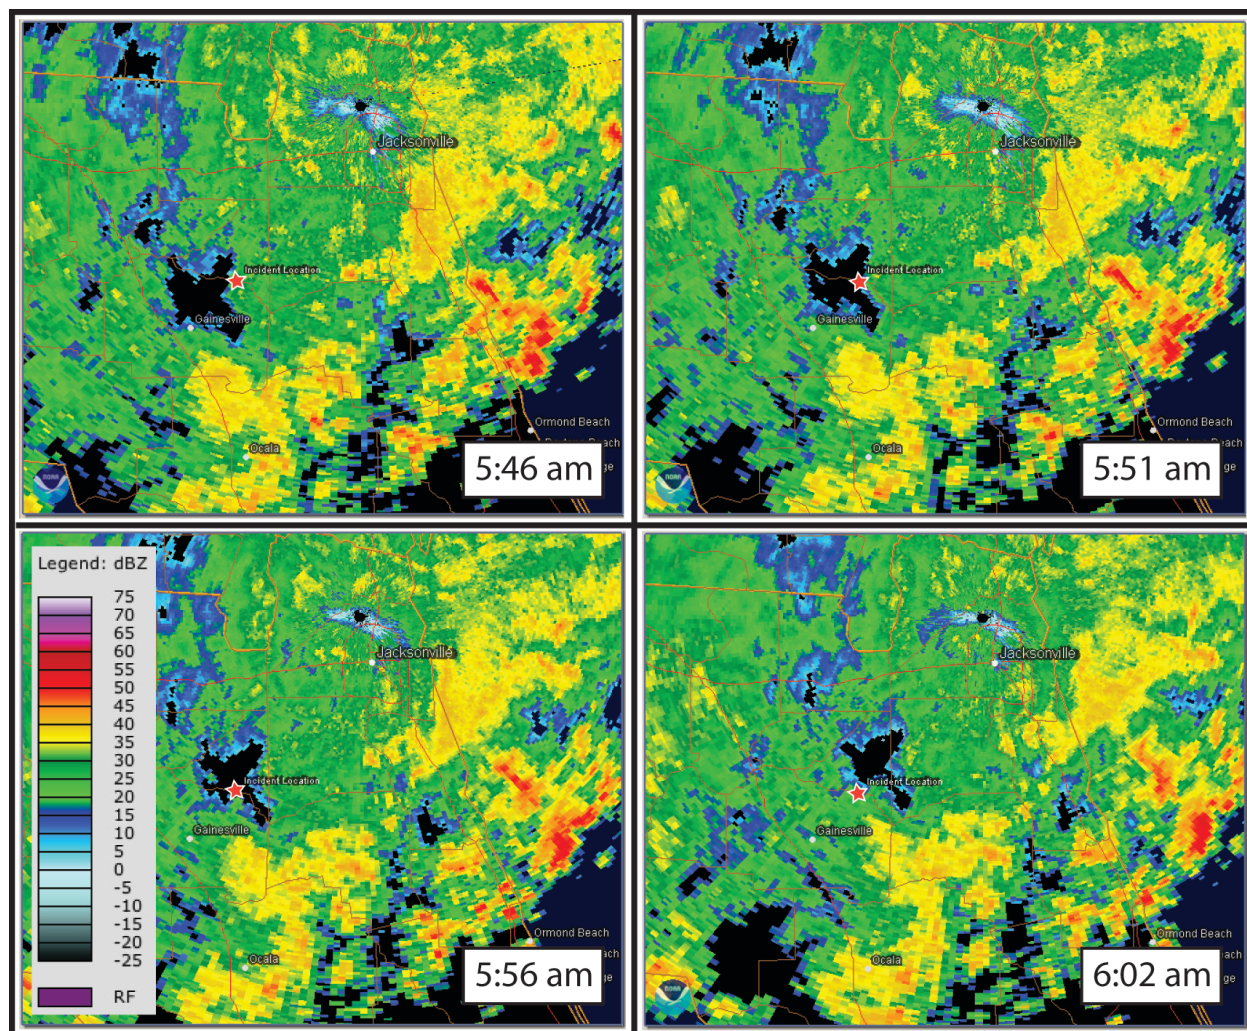
Figure 2: KJAX radar base reflectivity for the 0.5° elevation angle during the time of the accident. By this time, the leading edge of the MCS had weakened and moved offshore. Light stratiform rain was affecting the incident location (marked by a red star).
